POST OCCUPANCY EVALUATION
LEARNING FROM TODAY TO PROVIDE A BETTER TOMORROW

W. S. Cumby & Son

In September of 2007, Todd Reed and Cam Fitzgerald of Energy Opportunities visited W.S. Cumby's office and conducted a POE study.

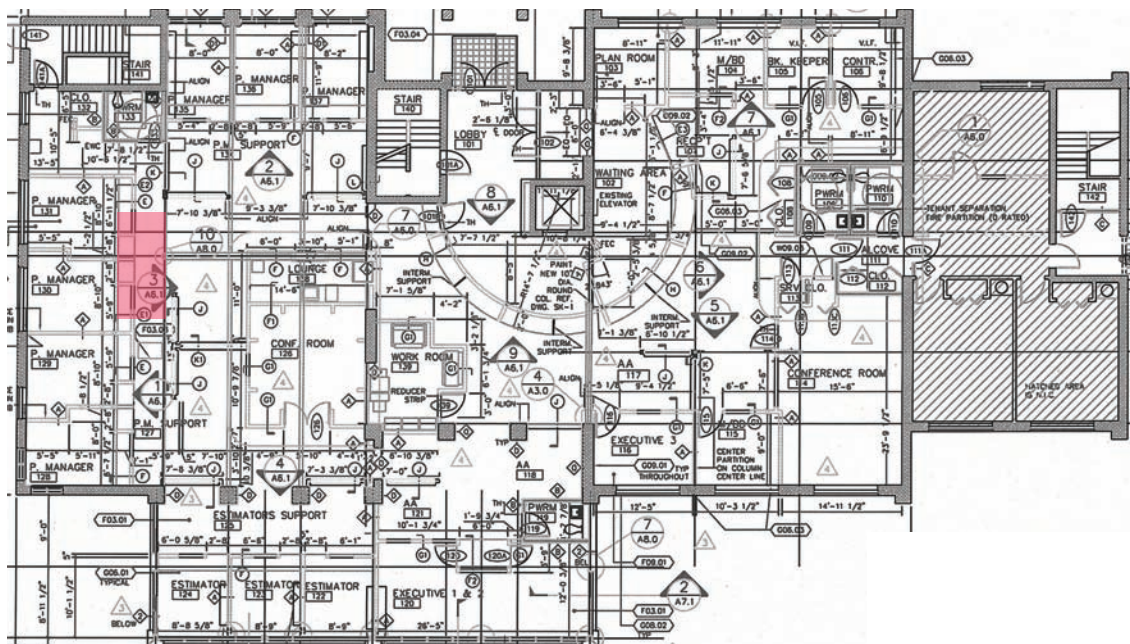
The highlighted area shows the location for the IAQ Test conducted. This occurred in the vaulted open office area.

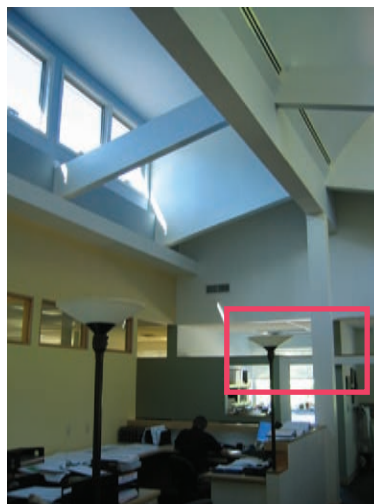
An indoor air quality test was performed at the project's location. The test kit used was from Air Quality Sciences, Inc. (Please See Appendix for complete test kit information and results.) Each test kit was capable of testing for VOCs, formaldehyde, and mold spores. There were limitations with these kits, as they could only effectively test 1,000 sq ft of space. An atypical space was chosen for the placement of the kit. The testing tubes were left in place for one week's time and dust samples were taken from the headers to the work spaces shown in the picture.

This image shows the location of the IAQ test tube locations and where the dust samples were taken.

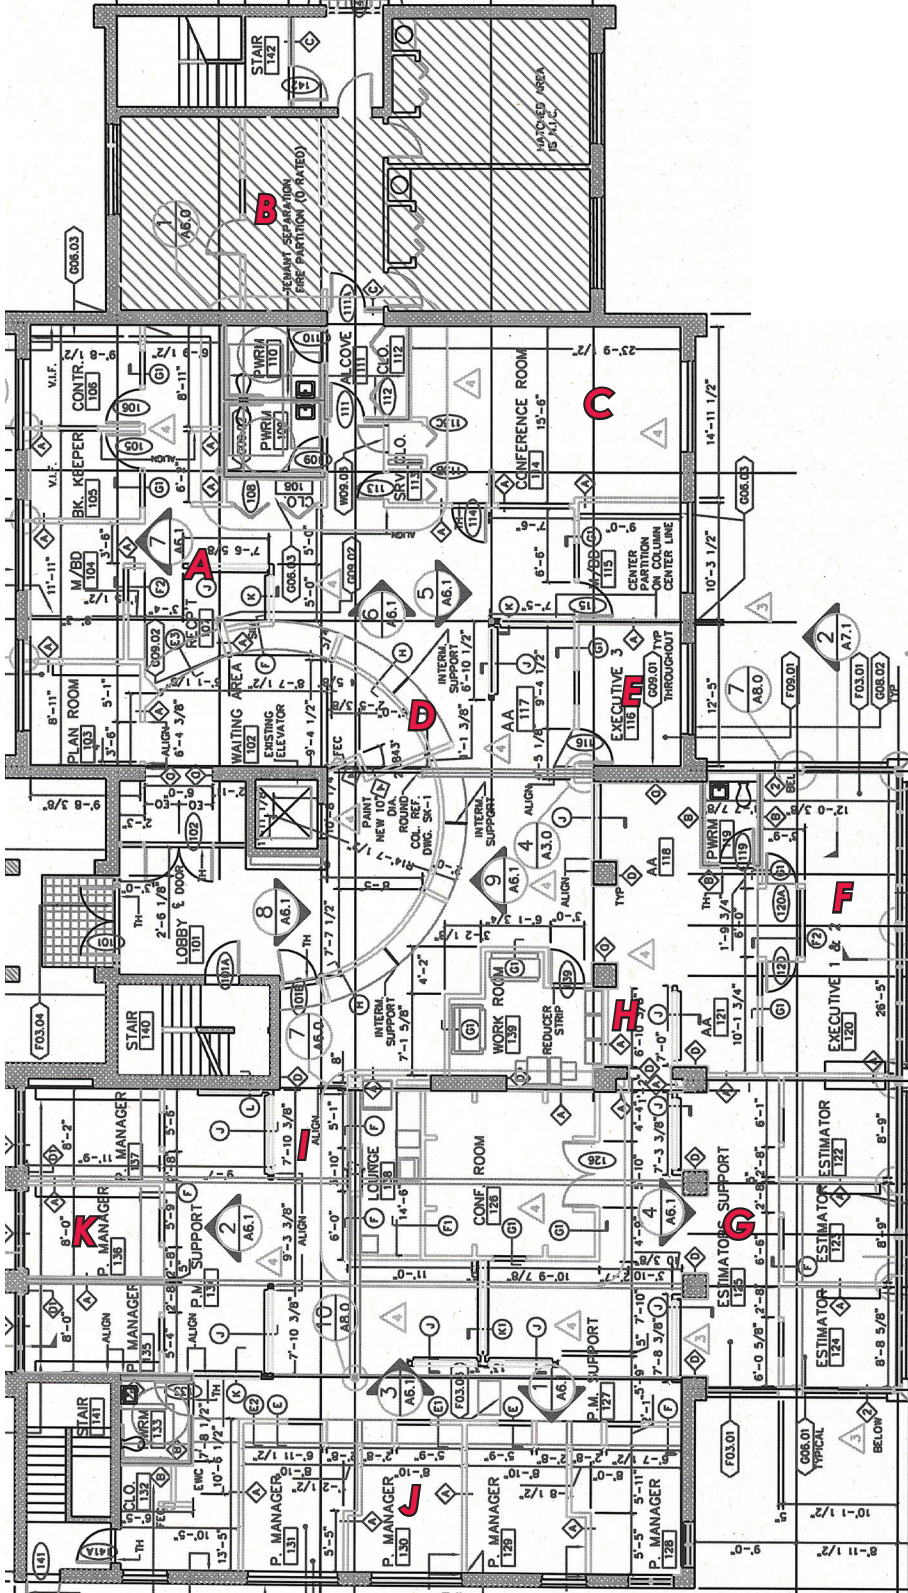
Readings were taken throughout the building for CO₂, temperature, and relative humidity. The office had about 20 people inside at the time of the readings with the outside measurements being 68.9 F, 57.3% relative humidity, and 662 ppm of CO₂. The windows were closed at the time of the readings. The CO₂ levels were on average 19% more than the outside readings. No indications from the occupant survey show any complaints of air quality. The project did not attempt CO₂ monitoring or increased ventilation.

Temp	Humidity	CO ₂	Occupied
A	74.3	48%	782	yes
B	74.3	49%	923	yes
C	73.4	50%	902	no
D	74.3	48%	814	no
E	73.4	49.60%	762	no
F	73.4	48%	786	no
G	73.4	47.40%	843	yes
H	73.4	47.80%	832	no
I	73.4	49.30%	762	yes
J	73.4	48.90%	781	no
K	73.4	49.50%	804	yes

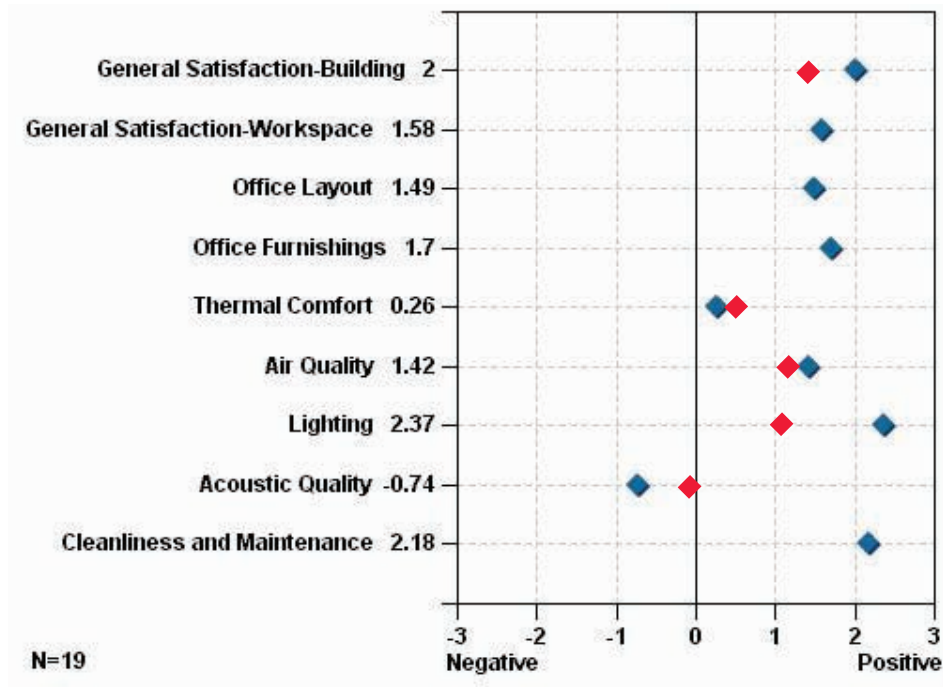
The chart above shows the project's overall results (blue diamonds) from the survey. The red diamonds represent the average results of 15 surveyed LEED certified buildings. (See Appendix for full report) The report titled "Occupant Satisfaction with Indoor Environmental Quality in Green Buildings" was conducted by the Center for the Built Environment which surveyed 215 different buildings. The survey consisted of LEED certified, green designed, and ungreen designed buildings.

As summarized in the report, acoustics and lighting were among the two lowest amongst green buildings. The reason for this is that most green buildings implement open floor plans to increase the overall penetration of daylight into the space. These open floor plans can have poor acoustical qualities, resulting in the low ratings.

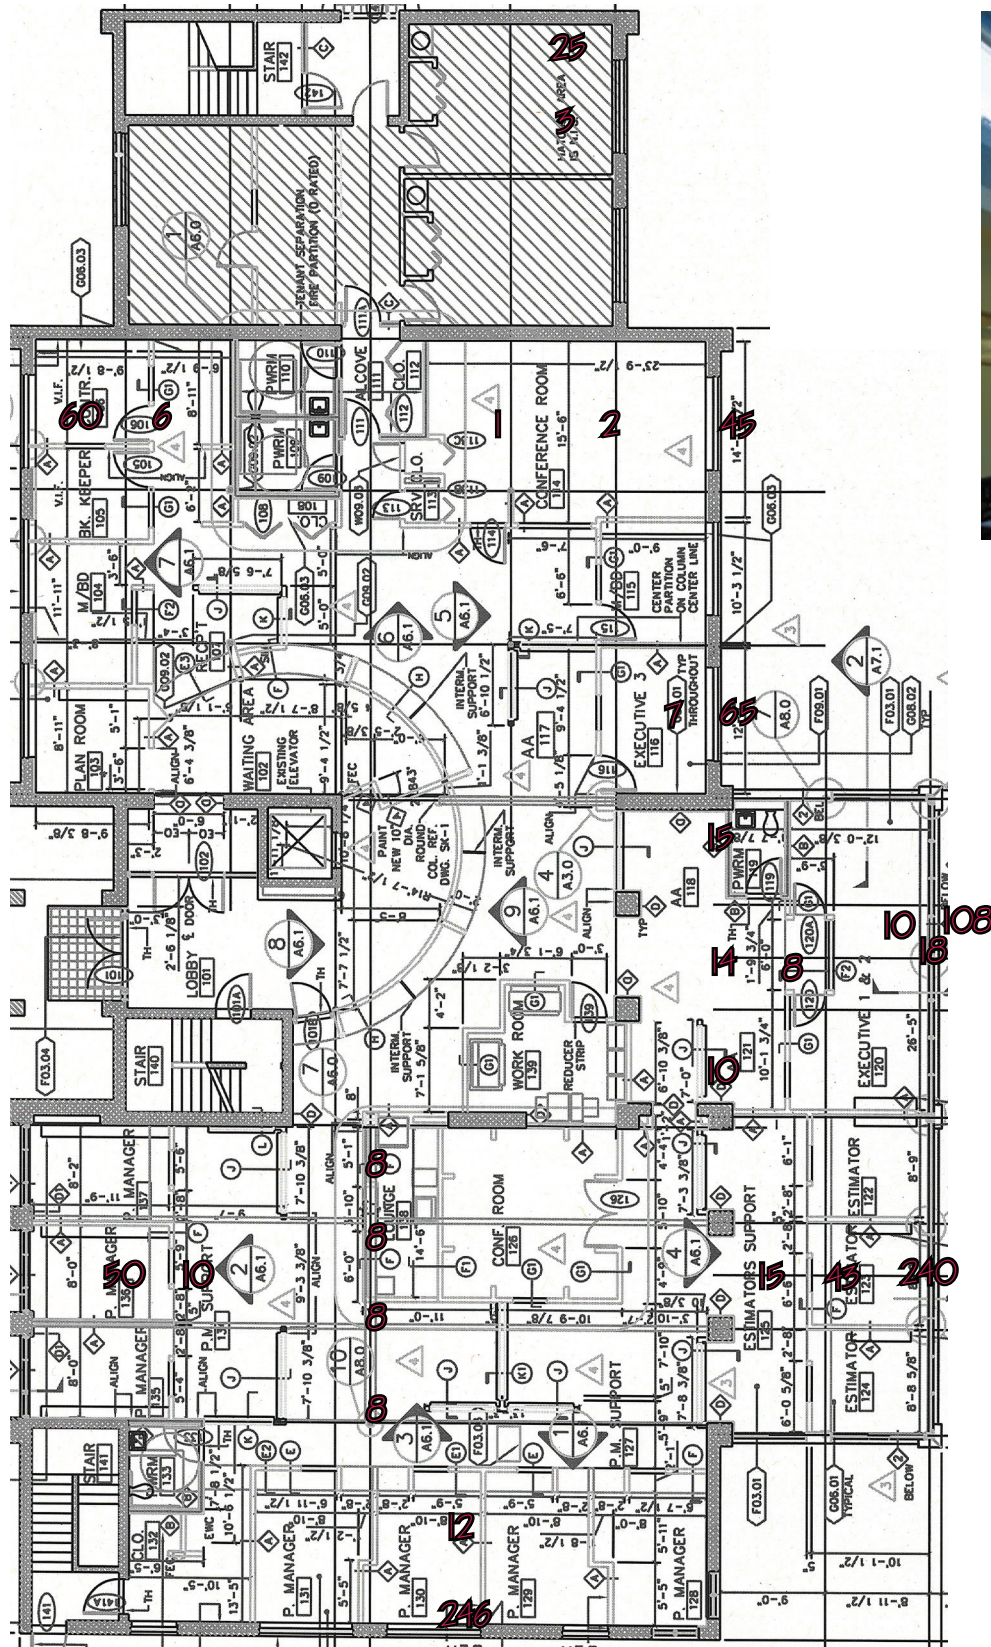
LIGHTING

Overall, the occupants were satisfied with the lighting levels in the building. Below are the measured lighting levels throughout the project on September 19th at 10:30am. 30 fc = a daylight factor of 2.

A typical daylighting zone is usually 1.5 to 2 times the window head height. The project is surrounded by a large amount of vegetation, which results in considerable shade. This is good for the reduction of solar heat gain, but is detrimental to the daylight levels in the space.

Typical lighting levels for an office space are, at a minimum, 20-30 fc. The majority of the spaces adjacent to the window wall have sufficient levels of daylight. Some of the spaces on the northern side of the project are lower than optimum.

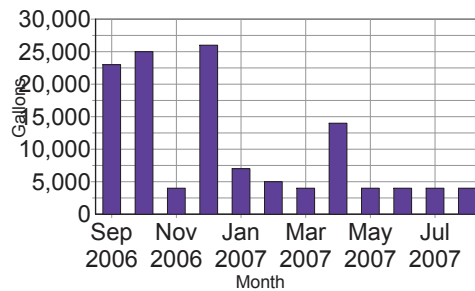
Water Consumption

The actual water usage during the period September 2006 through August 2007 was 124,000 gallons. During this period, there were four months of anomalous data. September, October and December 2006 all exceeded 23,000 gallons per month. April 2007 was 14,000 gallons. None of the remaining eight months exceeded 7,000 gallons of usage. It is unclear why the consumption during these four months is so much higher than the norm. Averaging the non-anomalous months results in a usage of 4,500 gallons per month. Extrapolating for a year equals 54,000 gallons which is significantly closer to the prediction.

Water billing should be closely tracked to ensure that the causes for the high usage can be identified and addressed to ensure continued water savings in the future.
