State College Area School District  
Ferguson Township Elementary School  
**Preliminary Daylight Analysis**  
**October 1, 2009**

The purpose of this analysis is to determine the daylight performance of the design as of September 2009 and to provide performance recommendations.

The target performance goal of the project is to achieve an average DAR of at least 45% in all core learning spaces and 80% in the gymnasium. The minimum illuminance value for determining the DAR for the core learning spaces is 35fc and 30fc for the gymnasium.

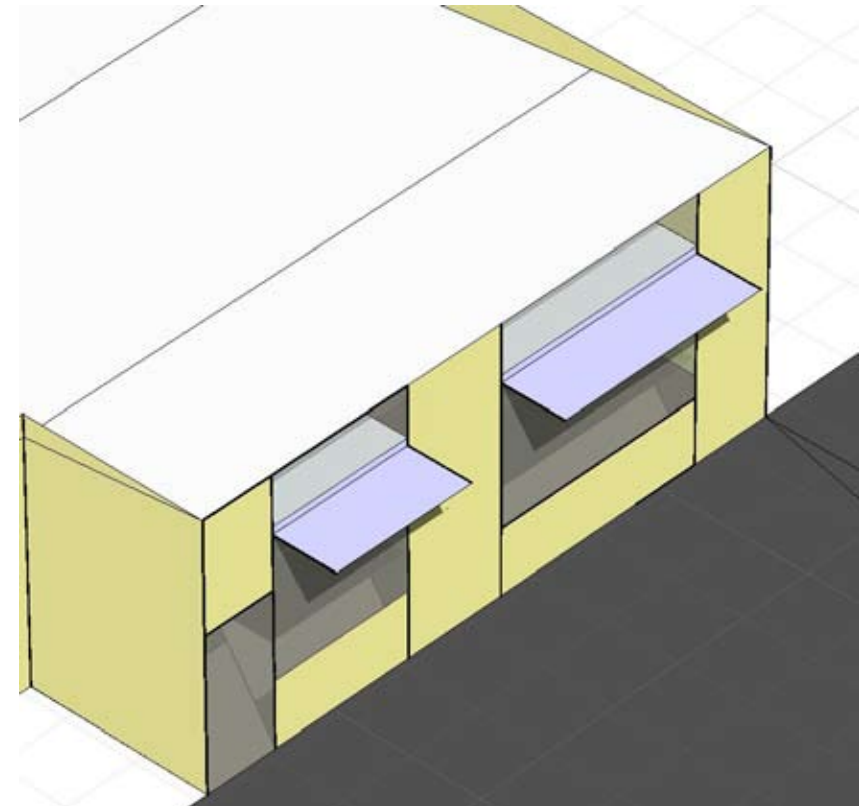
Mar 21st 12pm

The project's orientation presents some situations that need responded to in a specific manner. The southern elevation of the classroom wing is orientated southeast. As shown in the image above, the exterior shading devices in their current size do not provide 100% shading for the classrooms.

It is recommended that the exterior shading device extend at least 1'-6" beyond the western edge of the window. Because of the orientation, the shade does not need to extend beyond the window edge on the eastern side. This is due to low sun angles.

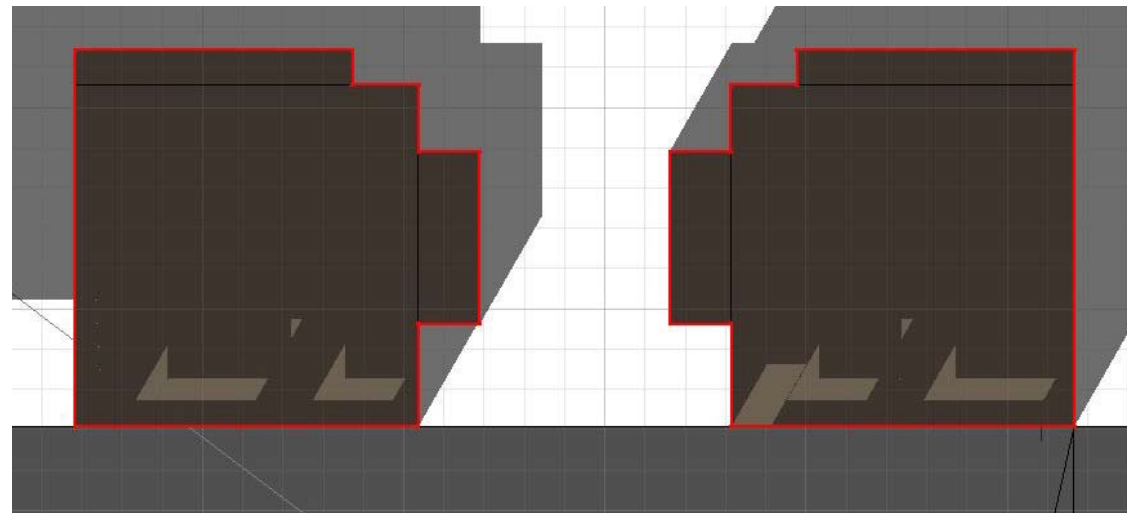
First Floor Classrooms March 21st 12pm

As shown in the images above, the exterior shading device needs to extend beyond the western edge of the window. Direct solar will be an issue from 8am till 10am from March to June and August to October.

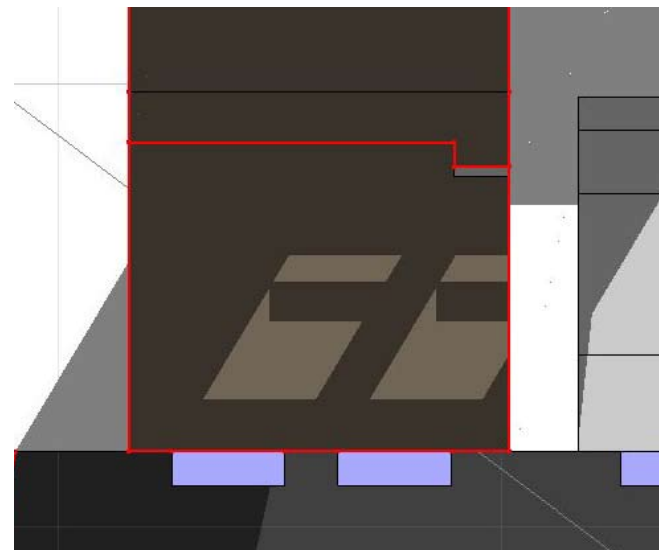
Second Floor Classrooms Feb 21st 12pm

In the winter months, November to February, direct solar will be an issue from 8:30am till 2pm under clear sky conditions.

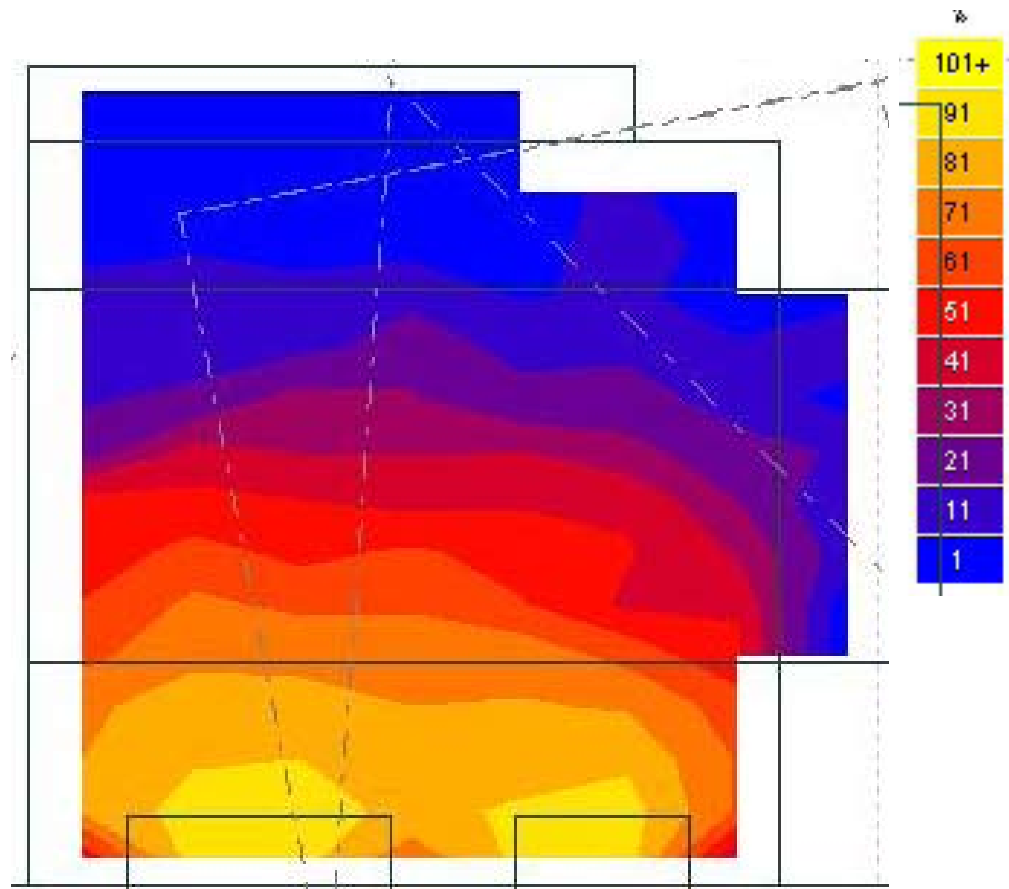
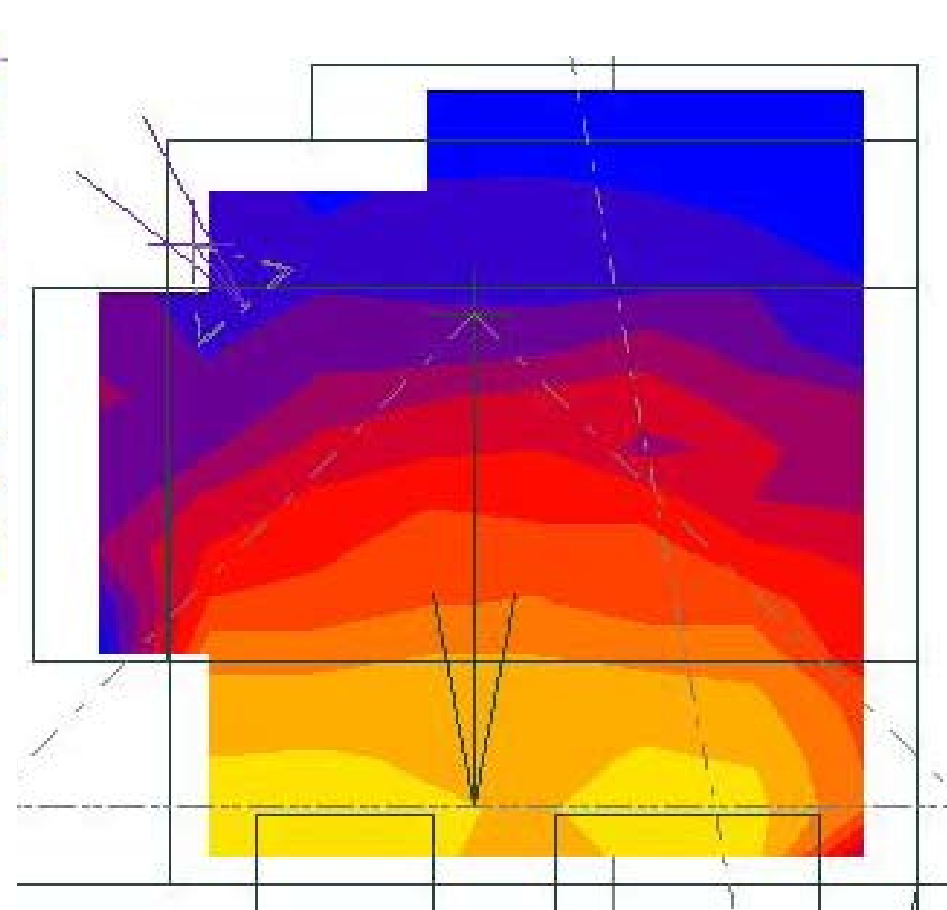
# 1st Floor South Facing Classrooms

The first floor south facing classrooms were modeled with the following parameters.

**Internal Reflectances;** Floors 40%, Walls 70%, Ceiling 80%, Light Shelf 70%.

**External Reflectances;** Ground 26%, Exterior Shade 70% w/30% transparency.

**Glazing;** View window 60%, Daylight window 70%.

**Min. Target Illuminance;** 35fc

The classroom on the right was modeled with a door and the one on the left was not as a comparison. As shown in the DAR images, the targeted DAR is being met for at least 50% of the space. The bottom images are at 12pm on March 21 under overcast sky conditions, which is the worst case scenario. Those snap shot images help validate that only 50% of these spaces are meeting the target levels.

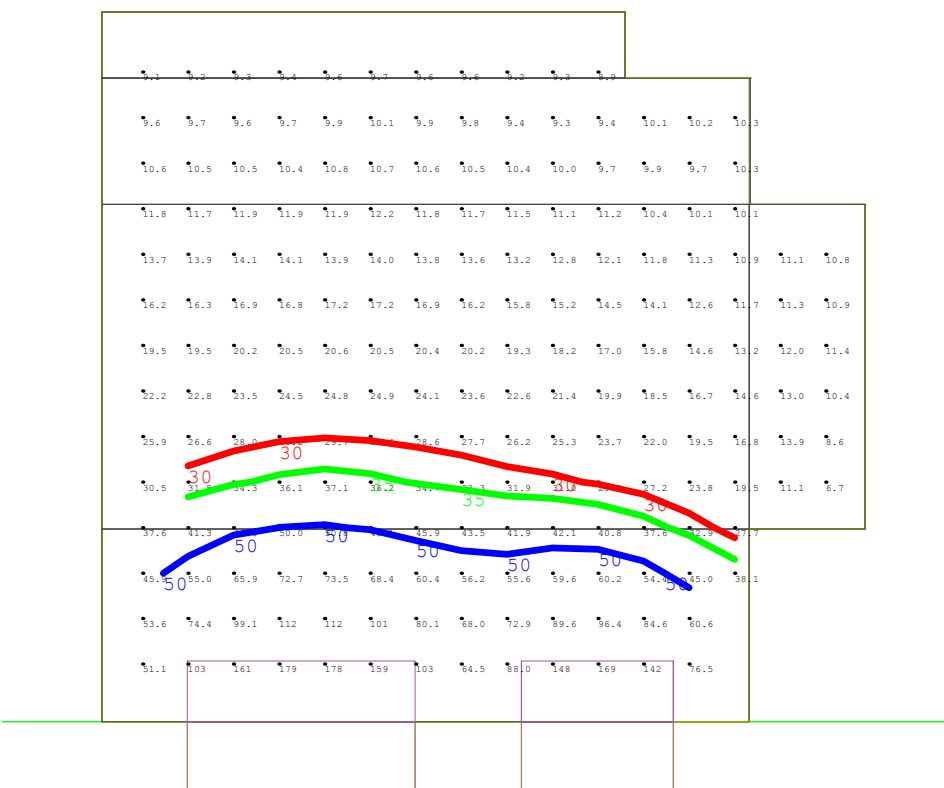
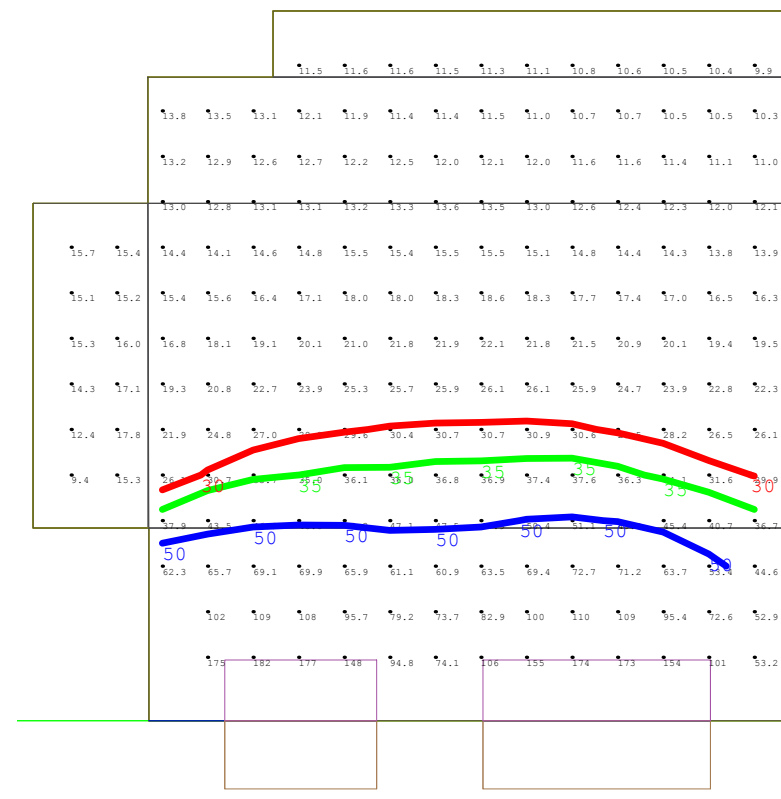
# 1st Floor North Facing Classrooms

The first floor north facing classrooms were modeled with the following parameters.

**Internal Reflectances;** Floors 40%, Walls 70%, Ceiling 80%, Light Shelf 70%.

**External Reflectances;** Ground 26%,

**Glazing;** 70% VLT

**Min. Target Illuminance;** 35fc

The targeted DAR is being met for almost 75% of the space. The smaller luxor image from March 21 under overcast sky conditions validates the illuminance levels.

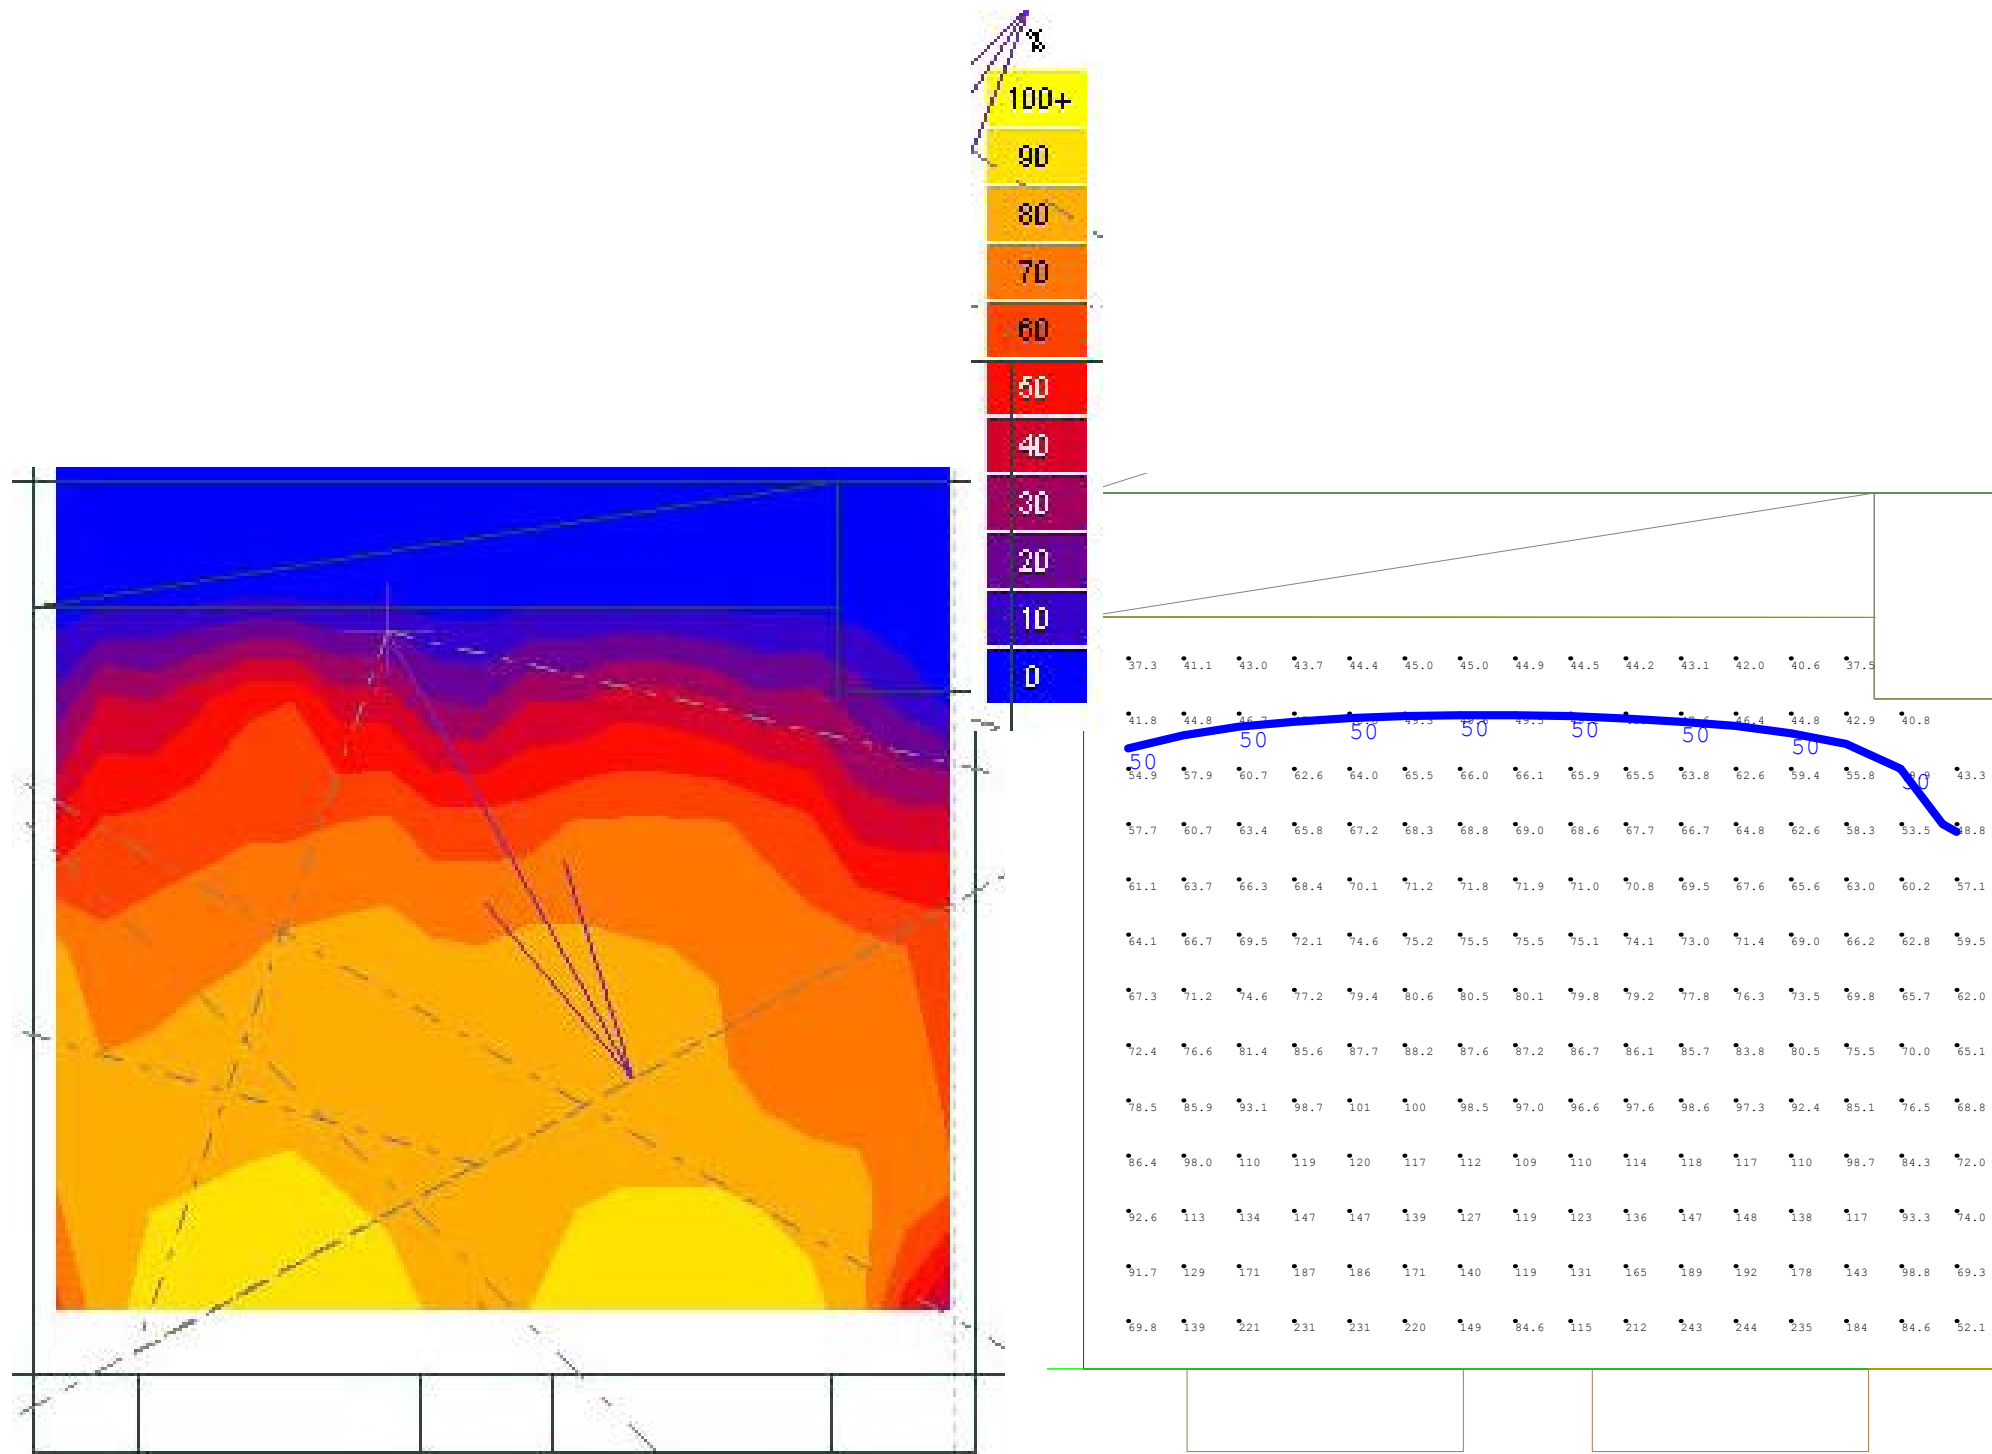
## 2nd Floor South Facing Classrooms

The second floor south facing classrooms were modeled with the following parameters.

**Internal Reflectances;** Floors 40%, Walls 70%, Ceiling 80%, Light Shelf 70%.

**External Reflectances;** Ground 26%, Exterior Shade 70% w/30% transparency, Roof 65%.

**Glazing;** View window 60%, Daylight window 70%. Clerestory 70%

**Min. Target Illuminance;** 35fc

The largest portion of the space is meeting the target DAR. This due to the bilateral daylighting condition.

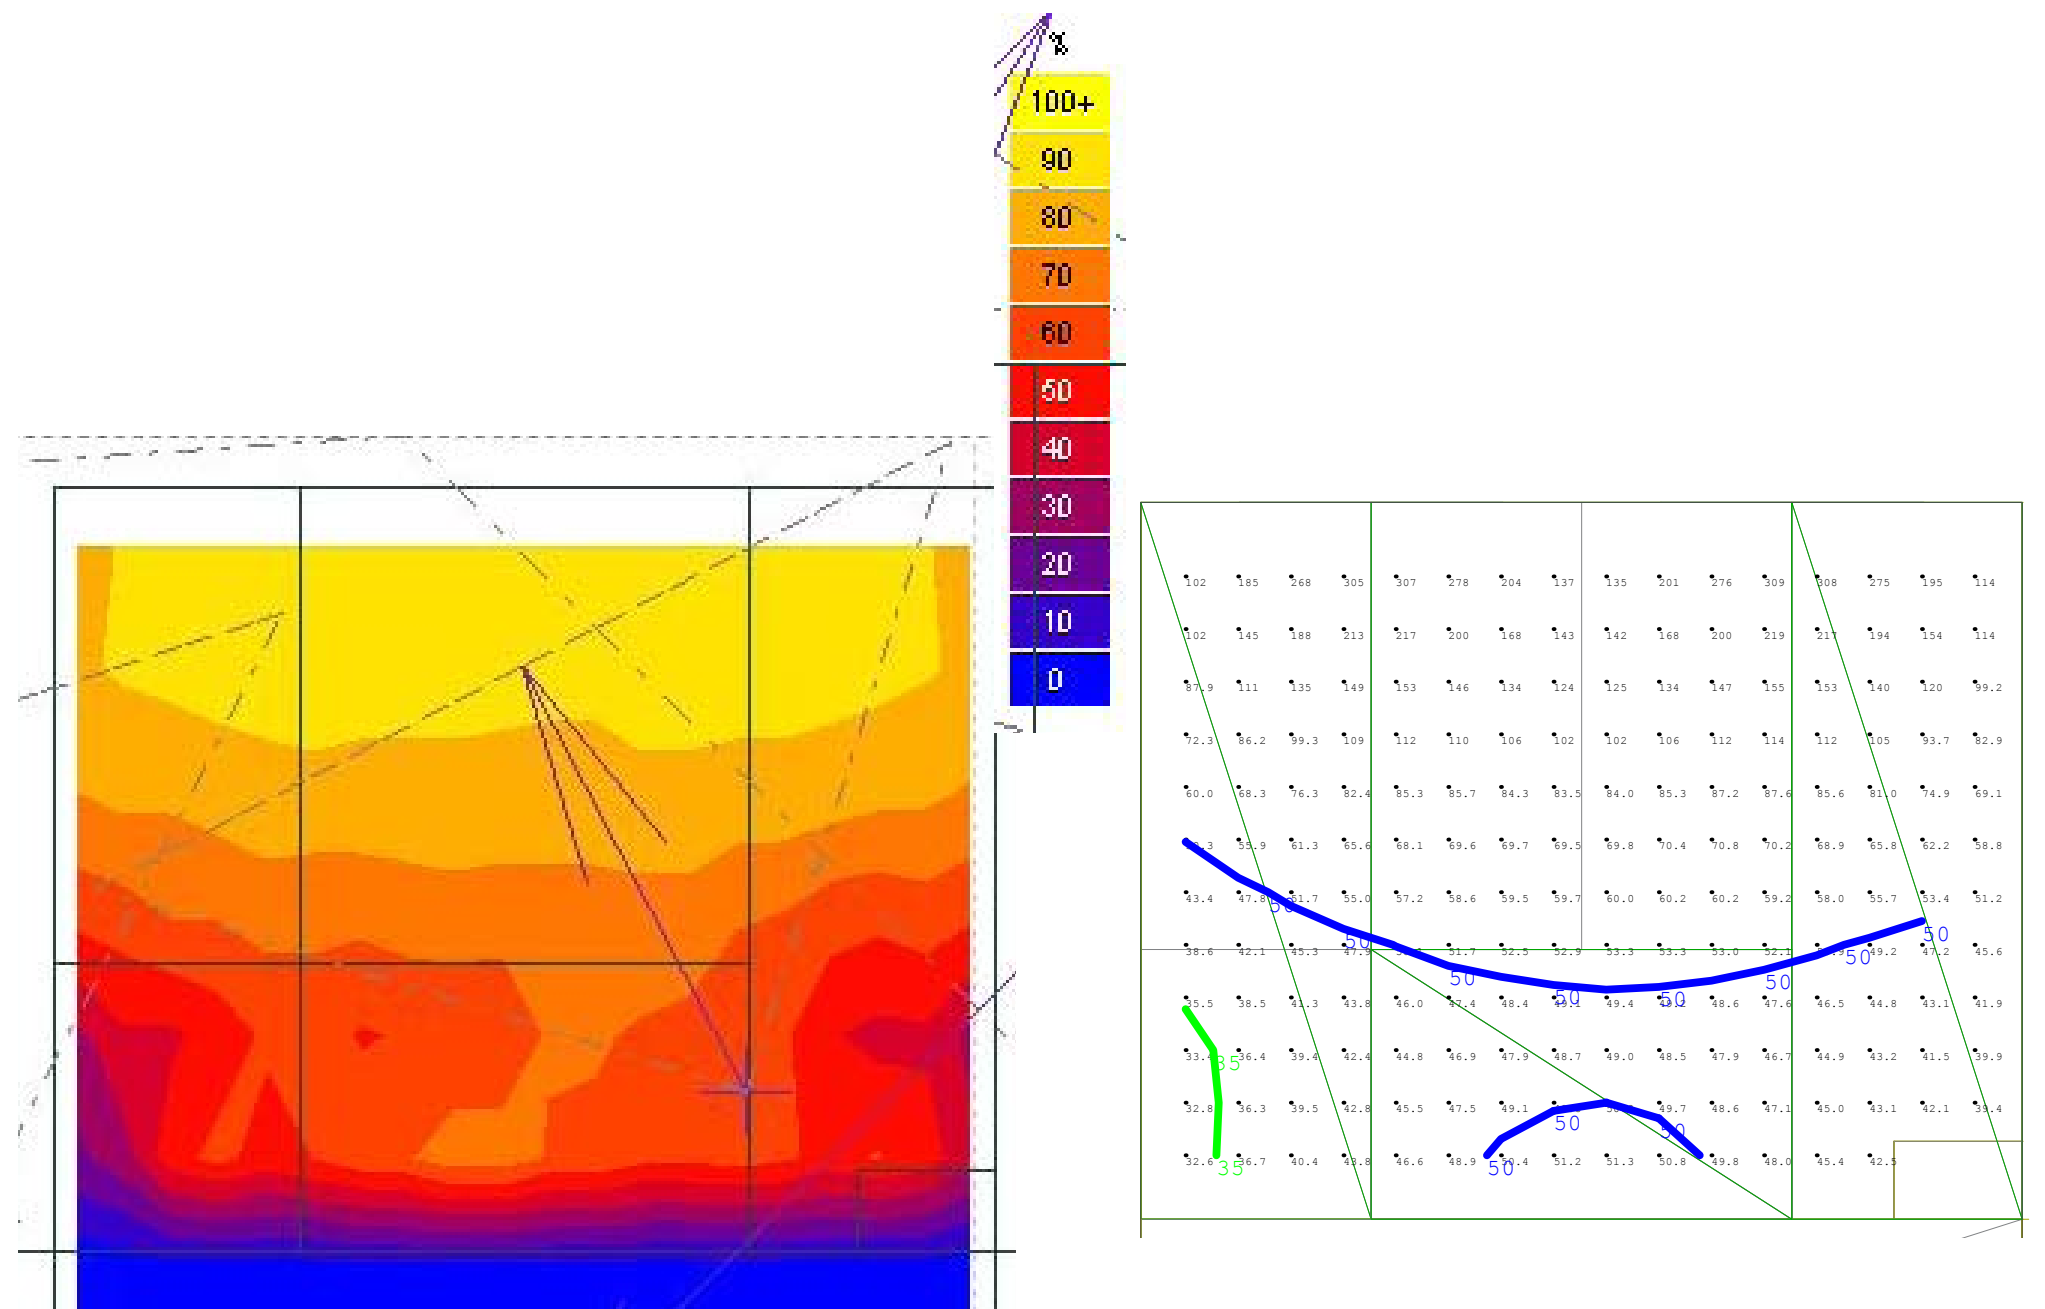
## 2nd Floor North Hallway

The second floor hallway was modeled with the following parameters.

**Internal Reflectances;** Floors 40%, Walls 70%, Ceiling 80%, Light Shelf 70%.

**External Reflectances;** Ground 26%, Exterior Shade 70% w/30% transparency.

**Glazing;** 89%

**Min. Target Illuminance;** 5fc

Due to the height of the space and the amount of glass that the light must pass through before it reaches many of the viewable surfaces of the space, it is recommended that the transom window be removed.

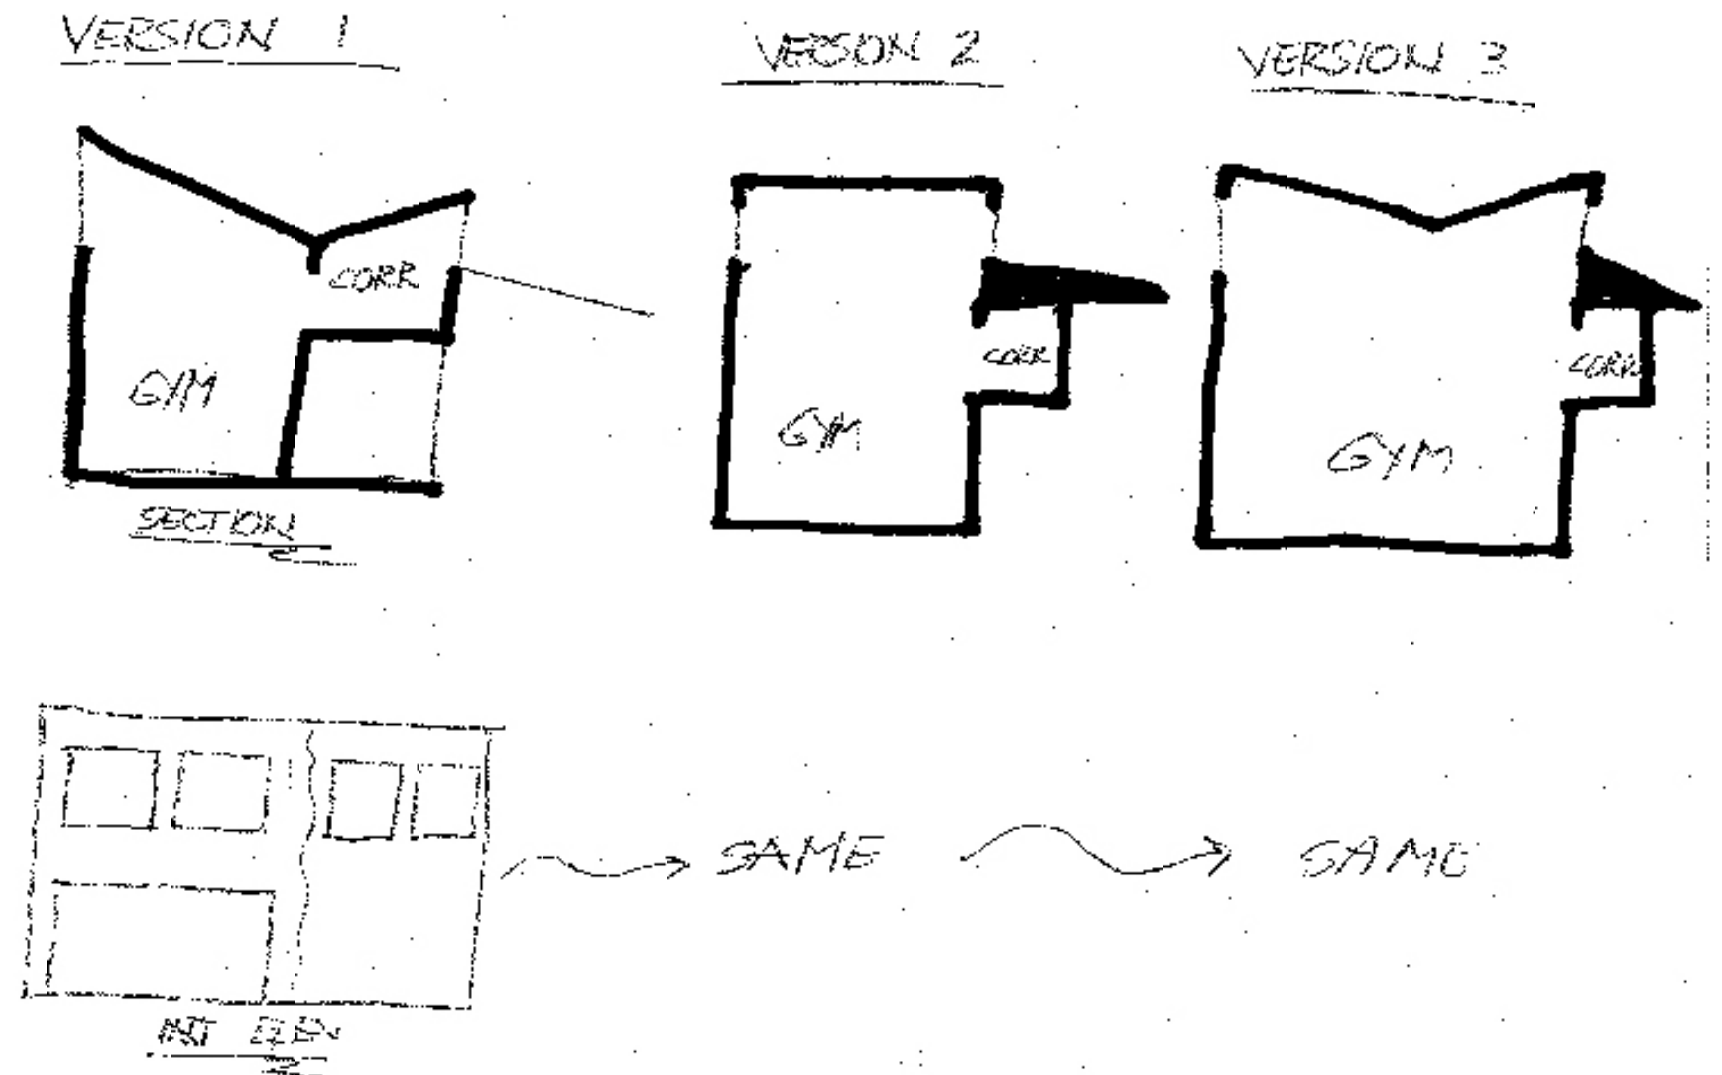
Three scenarios were run to look at three possibilities in effectively daylighting the gymnasium. Scenario 1 is the base design, Scenario 2 has a flat roof with the east clerestory located in the gym, Scenario 3 is the same as 2 except the roof is a butterfly roof.

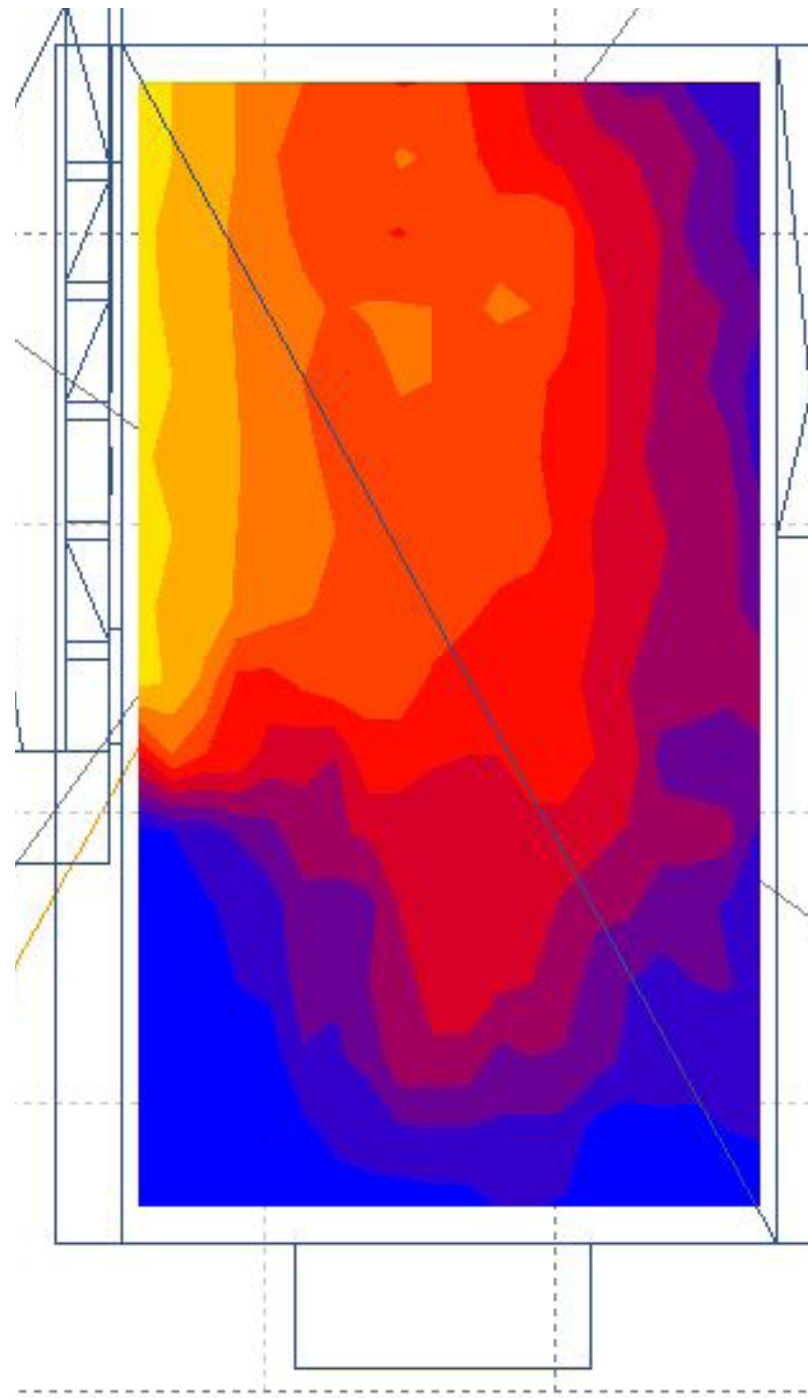
Scenario 3

The target DAR for the gymnasium is 80% with a minimum illuminance value of 35fc. The scenario that comes the closest to that goal and provides an even distribution of daylight in the space is Scenario 3.

To meet the daylighting goals and to provide the best quality of daylight into the space, it is recommended that scenario 3 is used.

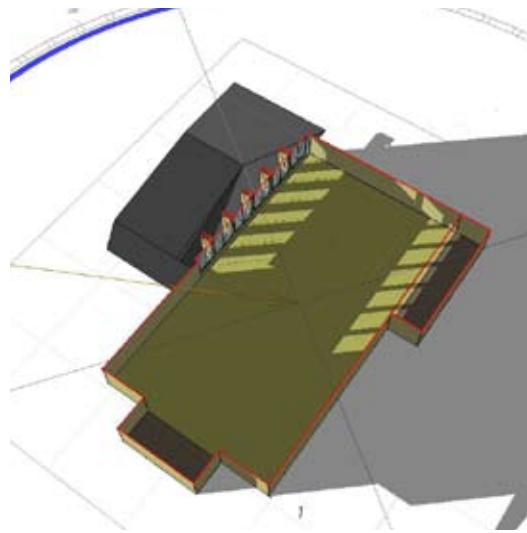
December 1pm

From the beginning of October till the end of March, there will be issues of direct solar penetration. In those months, this will occur during the school day. As the year moves on, from March until September, the effects will be greater later in the evening.
